DETAILED PROJECT REPORT

Flood Hazard Mapping & Drainage Analysis of
Kottayam Municipality,
Kottayam, Kerala

FLOOD VULNERABILITY & MITIGATION

August 2025

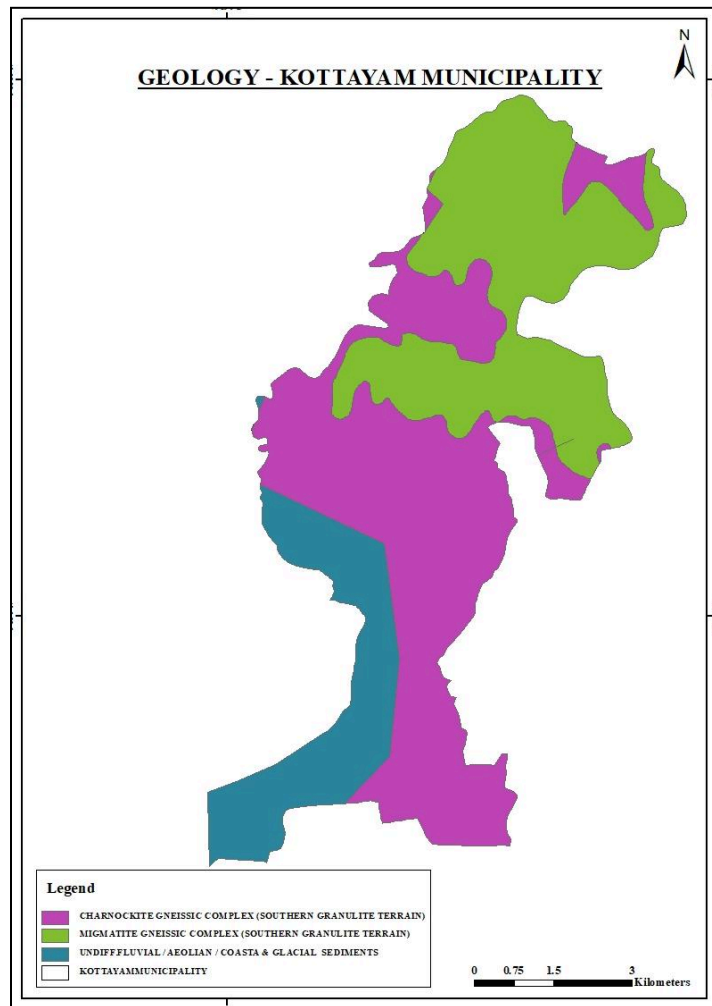
Figure 11: Geology map

Migmatic rock possess metamorphic characteristics. Metamorphic rocks formed under high temperature & pressure.

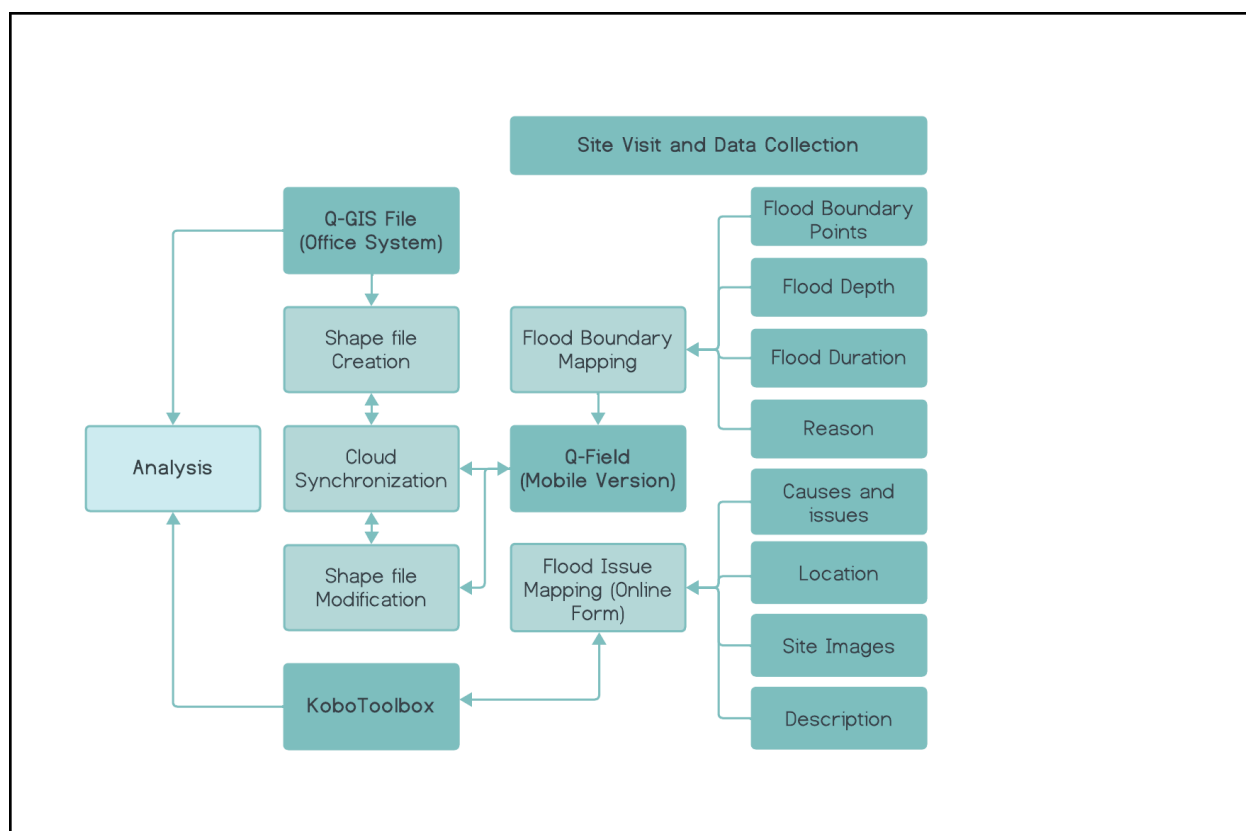
Figure 18 :Methodology for onfield data collection

This methodology integrates a combination of GIS software, mobile data collection tools, and cloud storage to create flood boundary maps that are both comprehensive and up-to-date. Extensive field visits were conducted across select wards, including Wards 3, 4, 5, and 6, to gain a deeper understanding of the specific flooding issues faced by Kottayam Municipality. These field visits allowed for direct observation of the flood-prone areas, infrastructure conditions, and the impact of environmental factors such as sediment accumulation, encroachment, and inadequate drainage. During these visits, technical teams assessed critical aspects such as riverbank stability, drainage blockages, and the role of local topography in exacerbating flood risks. Additionally, data on land use patterns, building density, and land elevation were gathered to support a more nuanced understanding of flood vulnerabilities. By combining field data with GIS-based analysis, the approach allows for real-time updates and provides a dynamic, accurate representation of flood risks in the area. This ensures that the flood boundary maps are not only up-to-date but also reflective of the actual conditions on the ground, facilitating more informed decision-making and effective flood mitigation strategies tailored to the specific needs of the municipality.

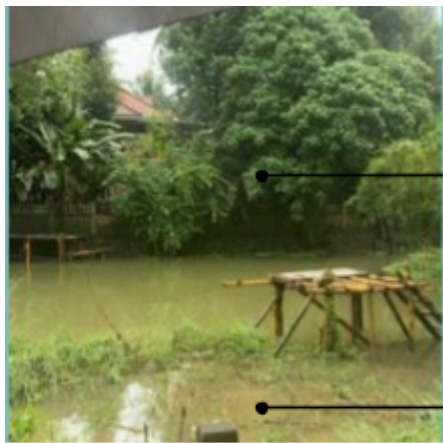
1. Encroachment - Plot Boundary walls are built over Side walls

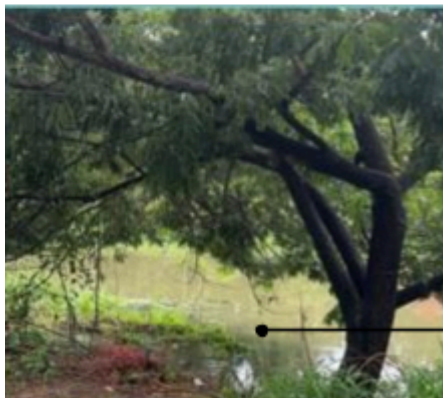
3. Decline in the Water carrying capacity (Depth and Width) of Meenantharayar - Due to Stilt Deposit and Encroachment

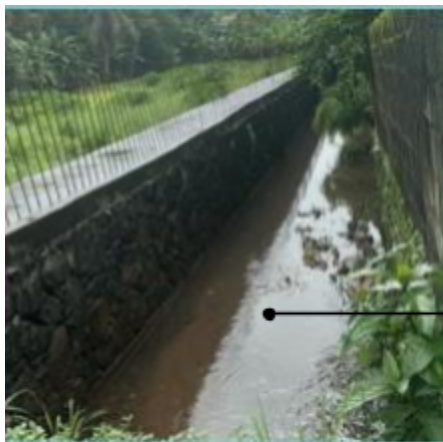
5. Polluted Natural drain - Due to the Pollutant discharge from the Armed Reserve Camp and other Structures in the highlands of Ward 14

6. Natural Drain - interrupted flow due to placement of grills to collect waste and bottle neck formed due to placement of Culvert

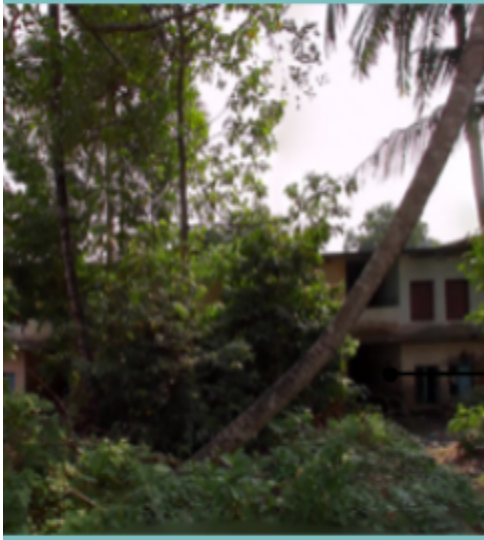
7. Abandoned Houses - due to Frequent Flooding (Lintel Level), Some of the Residents sold their property due to unsafe conditions

8. Flood After Effects - Many of the structures and houses are in risk of structural damage due to the moisture trapped inside the Walls which affects adversely on stability of House.

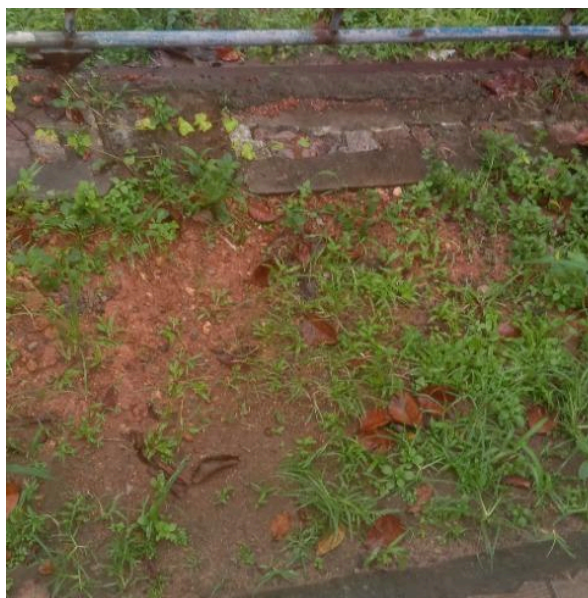
Figure 30: Encroachment On Streams

Encroachment is a significant issue in Pallippuram, manifesting in various forms across different parts of the area. A notable example is the encroachment of streams due to urbanisation, where small streams, initially measuring around 0.5 meters, are transformed into roads, disrupting the natural water flow. This can lead to flooding during heavy rains.

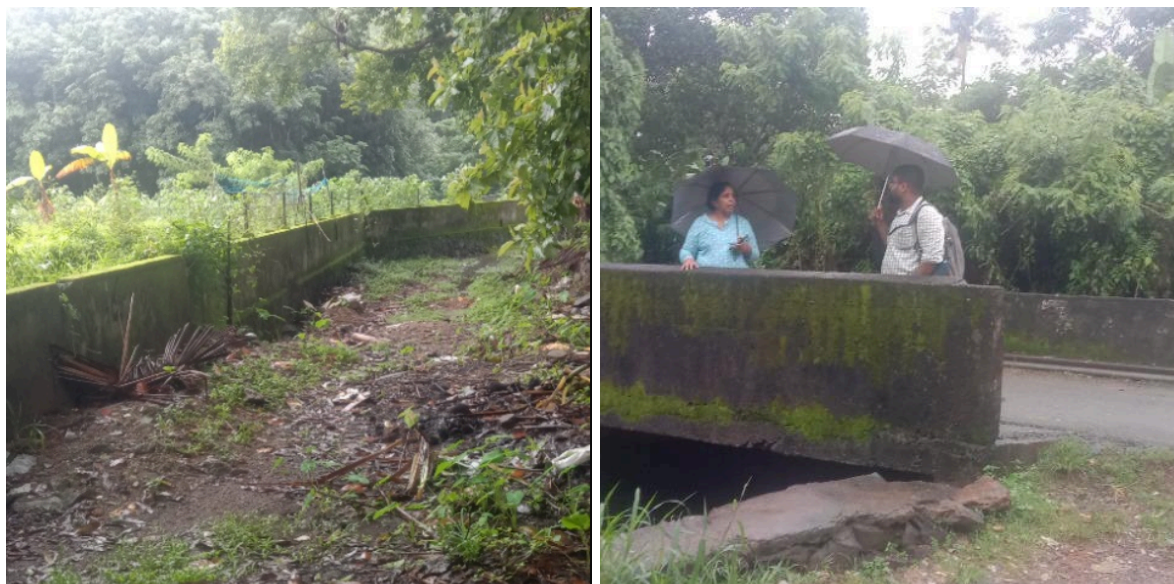
Figure 32: Blocked drain due to compound wall and bridge

Blocked drains are one of the causes of urban flooding in Pallipuram. In Pallipuram, you can see both urban and riverine flooding. Blocked drainage due to compound wall construction significantly restricts the flow of water into the Cherupayithodu stream during heavy rain, disrupting the natural flow and potentially forcing a shift in paddy field cultivation patterns. Furthermore, according to stakeholders, the Neelimangalam Bridge's height aligning with the road may raise concerns about water and debris backup during heavy rain events, potentially causing overflow. These factors collectively contribute to an increased risk of flooding and disruption of agricultural activities, highlighting the critical need for effective drainage and well-planned infrastructure development.

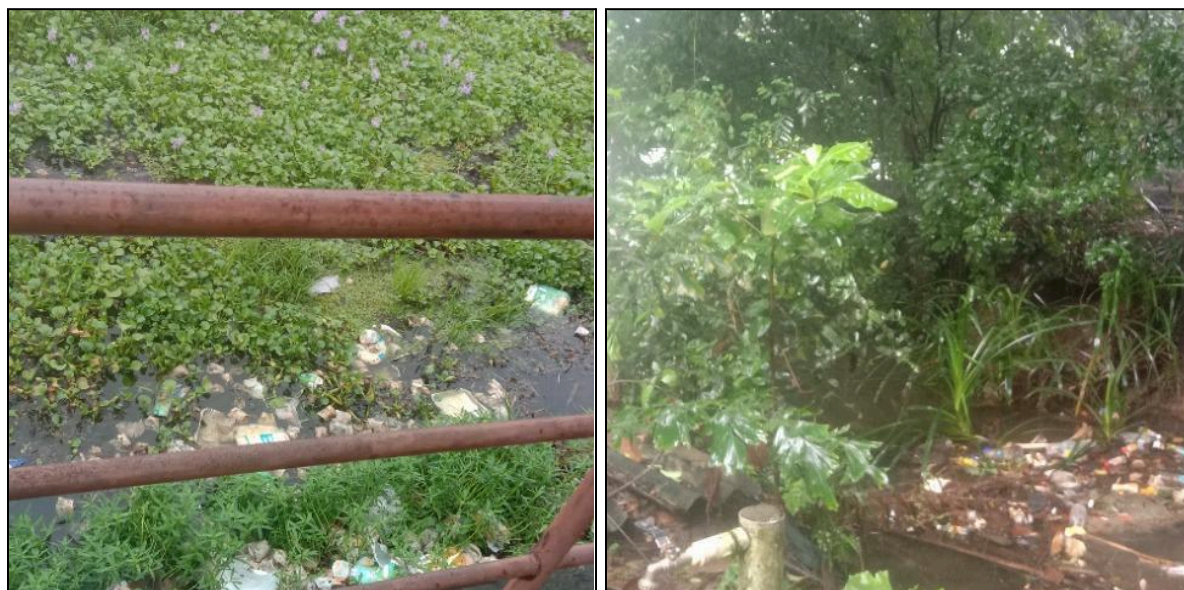
Figure 33 : Mosses\algae presence in the river *Figure 34: Dumping of waste*

Mosses and algae, along with dumped waste, are observed in the Pallipuram ward of Kottayam municipality. The presence of mosses/algae and the ongoing dumping of waste in

Cherupayithodu pose a significant threat to the surrounding areas. This buildup significantly reduces the watercourse's flow velocity and overall capacity to hold water, thereby increasing the risk of severe flooding. Immediate action, such as cleaning the waterway and implementing proper waste management strategies, is crucial to mitigate these flood risks.

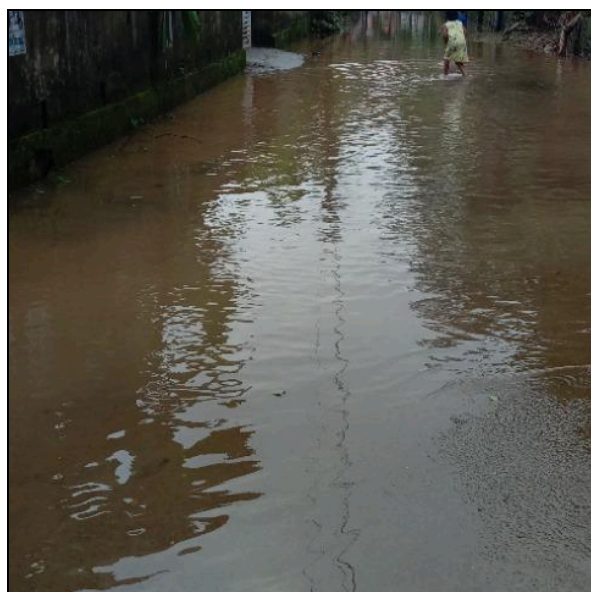
Figure 39: Absence of Drainage Facility

One of the significant issues in Puthettu is the lack of drainage facilities. In some parts of Puthettu, there is no drainage system available, which contributes to urban flooding in the area. In Attickalpadi Karindelli, the absence of drainage facilities leads to recurring floods, with rainwater only being disposed of through evaporation by sunlight. The disappearance of a canal in Puthettu hinders the natural flow of rainwater, causing severe waterlogging. The canal may get blocked by debris or silt, reducing its capacity to carry water. In response, local people have created temporary channels to manage rainwater flow, but these makeshift solutions are insufficient to address the persistent flooding problem effectively.

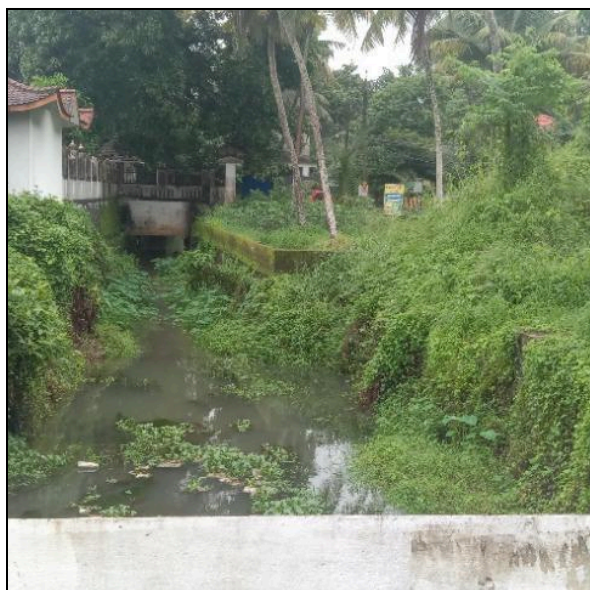
Figure 41: Encroachment Of River

gradient exacerbate these issues, potentially heightening the susceptibility to riverine floods in the region. In Choorakattil, such encroachment has already led to riverine flooding, causing structural damage in nearby areas.

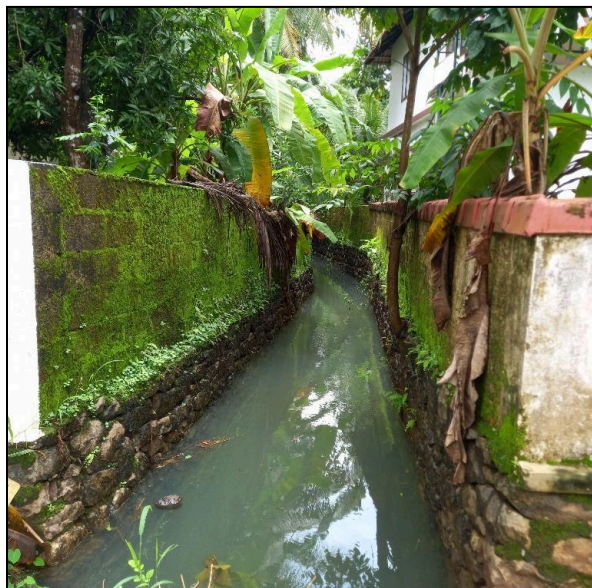
Figure 44: Encroached Stream

In Puthettu, blocked drainage is a significant issue contributing to flooding. The area faces problems with insufficient culvert capacity, where a drainage channel that was originally 6 meters wide has now been reduced to just 1 meter. This drastic reduction in drainage capacity leads to immediate flooding during heavy rainfall, exacerbating the flood situation in Puthettu.

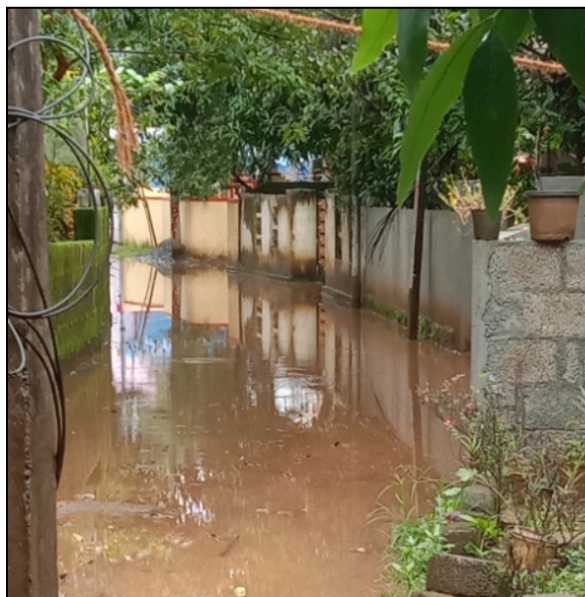
Figure 48: Blocked drainage in Paruthikuzhy

Nattasserry, restrict the natural flow of rainwater towards Cherupayithodu, leading to waterlogging even after a single day of rainfall and ultimately causing displacement of residents.

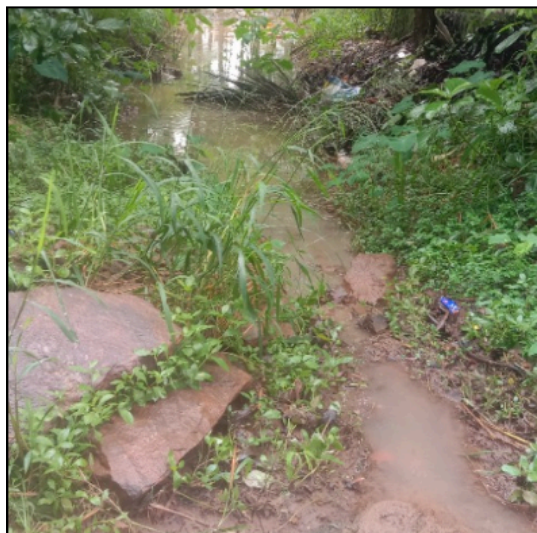
Figure 49: Absence of Culvert

The Kottayam municipality requires a sufficient number of culverts, as evidenced by the situation in Nattasserry, where the absence of culverts has led to significant issues. Previously, the Cherupayithodu stream connected to Karadhel Bridge without obstruction, but encroachment has now blocked this flow, transforming the area into a residential zone. Nattasserry, the use of pipes instead of culverts may cause problems such as blockage, debris accumulation, capacity limitations, and reduced flow efficiency, thereby increasing the flood risk in the area.

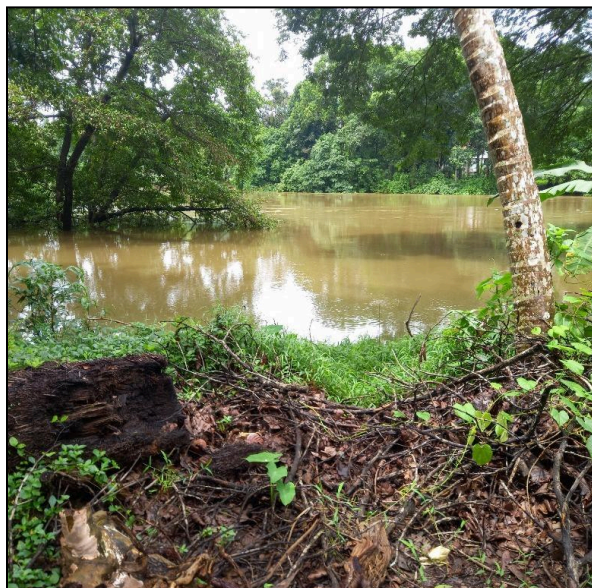
Figure 54 : Lack of side wall

In Parambuzha, we observed that the bund has been significantly damaged due to erosion from the riverbank, leading to restrictions on bus travel along this road out of concern for potential further damage. The absence of a proper sidewall along this section further increases the flood risk. Without a sufficient barrier, flooding can persist for up to seven days, with floodwaters overflowing more easily onto the road and surrounding areas, potentially causing more widespread inundation and property damage.

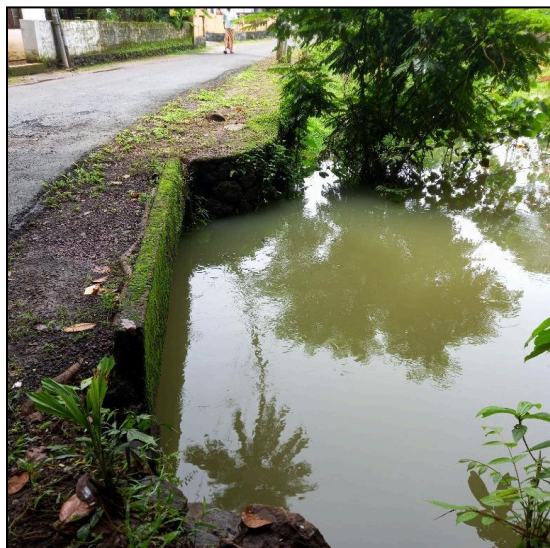
Figure 56: Insufficient Culvert

In Parambuzha, the insufficient dimensions of the culvert have caused one-meter-deep flooding for seven days as shown in Figure (). Another example in Parambuzha is the culvert, which was originally designed to handle six meters of drainage, now reduced to just one meter, drastically limiting its capacity to manage water flow as shown in figure (). This reduction in drainage capacity has led to prolonged and severe flooding, highlighting the urgent need for a sufficient number of adequately sized culverts. Without these improvements, the inadequate drainage infrastructure will continue to exacerbate flooding, leading to more frequent and severe inundation of the area.
